ECOLOGICAL ASSESSMENT

OF THE

ILLINOIS RIVER WATERSHED

ILLINOIS *River*
WATERSHED PARTNERSHIP

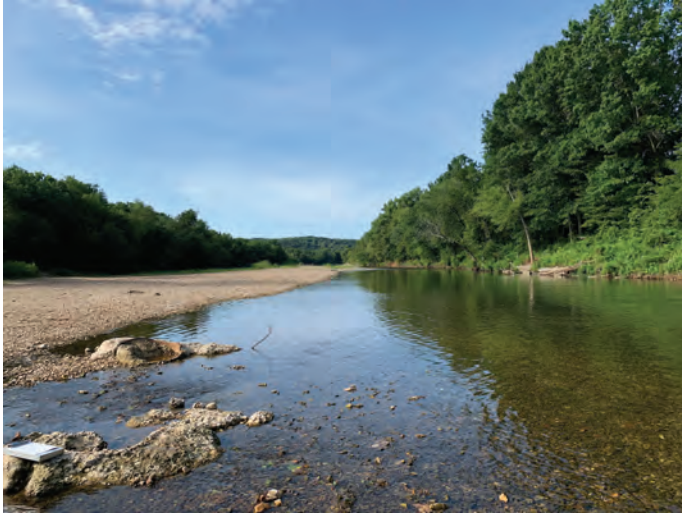
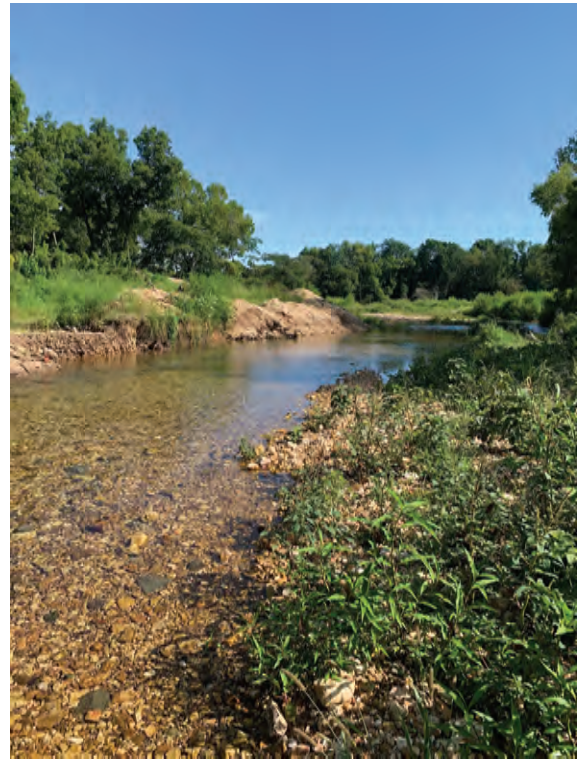
Visual Comparison of Sites with High and Low Numbers of Gravel and Cobbles Observations:

The Barren Fork site at left shows no active signs of erosion, though the gravel bar at left indicates erosion upstream from this site. The right-hand photo shows active signs of erosion, though at fairly low rates. This particular site did have high macroinvertebrate diversity, indicating that despite the active erosion, there is still enough diversity of in-stream habitat to maintain relatively healthy communities.

1. Permanent or semi-permanent land conservation
2. Restoration of riparian forests, wetlands, and floodplains
3. Sustainable livestock practices such as rotational grazing and fencing cattle out of streams.

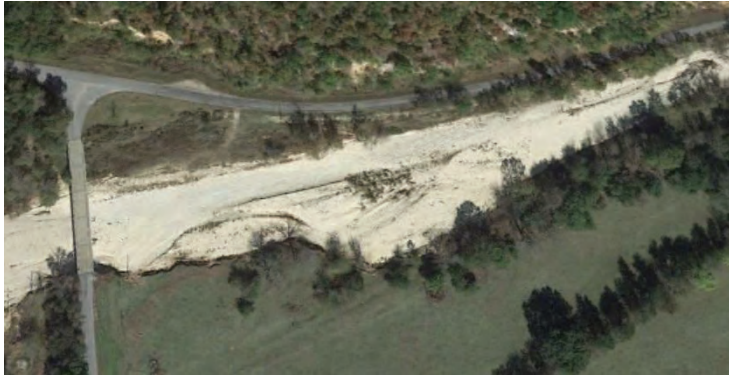
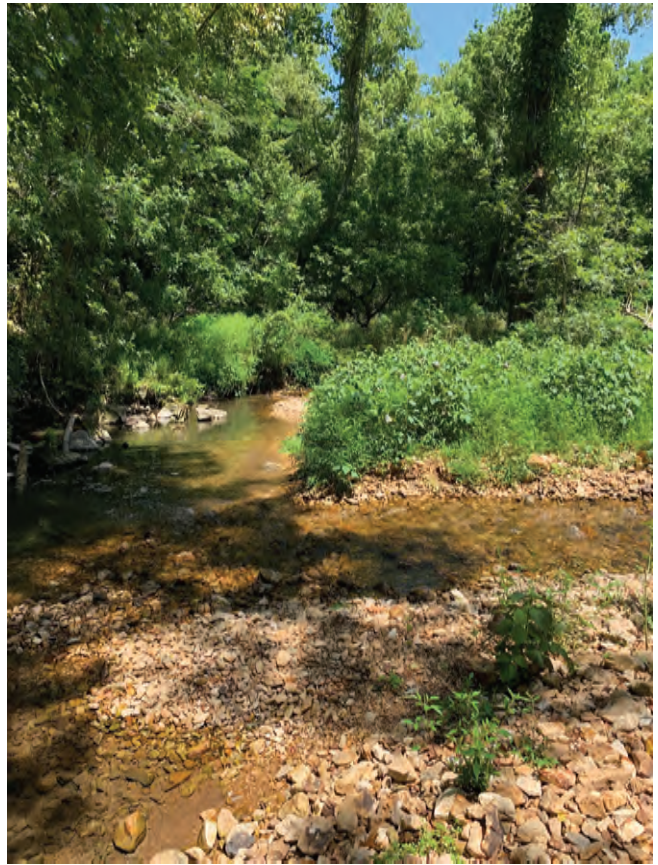
Visual Comparison of Sites with High and Low Numbers of Gravel and Cobbles Observations:

The site at left, located on the main stem of Caney Creek, is showing active signs of erosion and cattle have open access to the stream. Interestingly, the site was dry in August, but water was present at an upstream site, indicating subsurface flow for at least part of the year. The Caney site to the right is located on a tributary that is small, remote, and amid a large, forested parcel. Little to no active erosion is indicated by vegetation growing on the gravel bar and on the left streambank.

1. Permanent or semi-permanent land conservation of forested areas along waterways
2. Agriculture practices for cattle production
3. Wetland and floodplain restoration

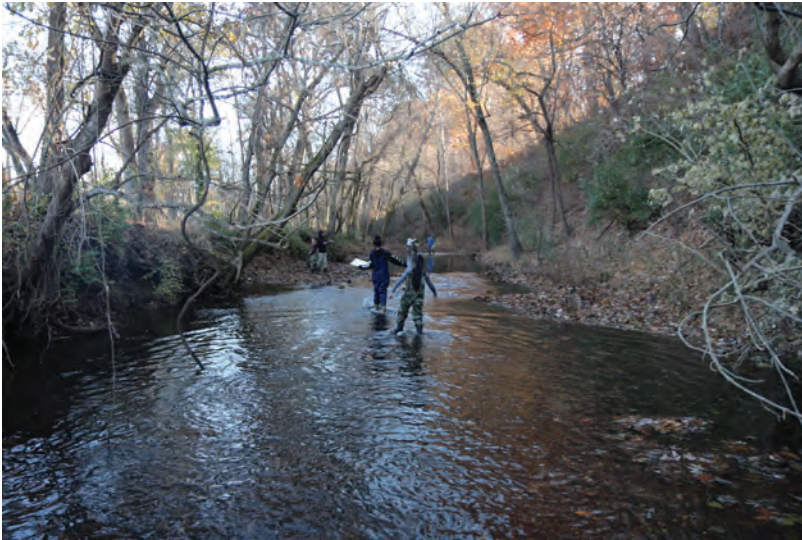
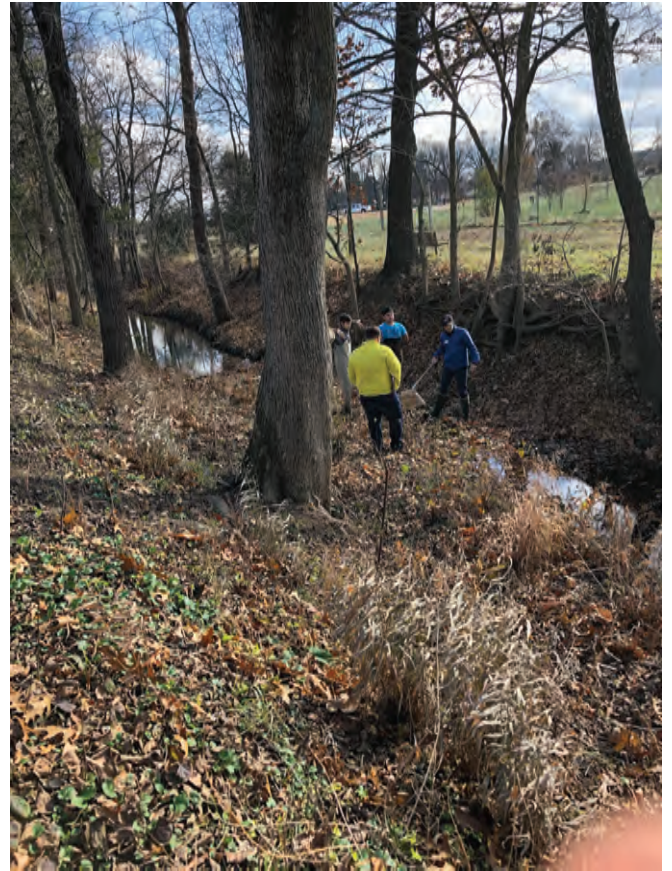
Visual Comparison of Sites with High and Low Numbers of Gravel and Cobbles Observations:

The Clear Creek site at the left recorded higher diversity and presence of gravel and cobbles than the site at the right, but both indicate “incision”. Incision is a common occurrence in urban creeks and streams and occurs when a creek or stream loses access to a wetland or floodplain. This leads to larger quantities and velocities of water, resulting in a snowball effect of erosion not only laterally along the streambank but also to lower elevations below the original streambed.

1. Permanent or semi-permanent conservation of undeveloped areas around waterways.
2. Low Impact Development practices for all parcels with residential or commercial development
3. Restoration of all incised stream reaches using natural channel design, followed by permanent conservation of surrounding land.

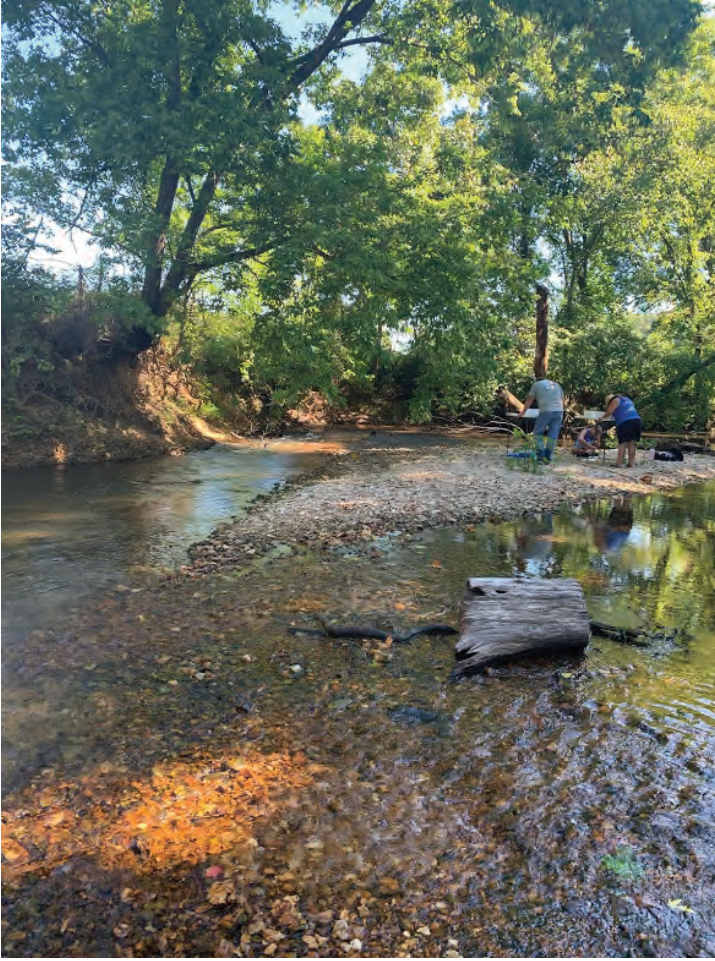
Visual Comparison of Sites with High Numbers of Gravel and Cobbles Observations:

There was little variation in quantities of silt, gravel, and cobbles or diversity among Flint Creek sites. Despite the eroded bank in the left-hand photo, the site still scored well, likely indicating that the rural land use types upstream of the site preserves streambottom composition, prevents silt and mud loading, and protects macroinvertebrate communities.

1. Permanent or semi-permanent conservation of all forested parcels (upland and lowland) throughout the subwatershed.
2. Sustainable practices for livestock production such as rotational grazing and fencing cattle out of streams.

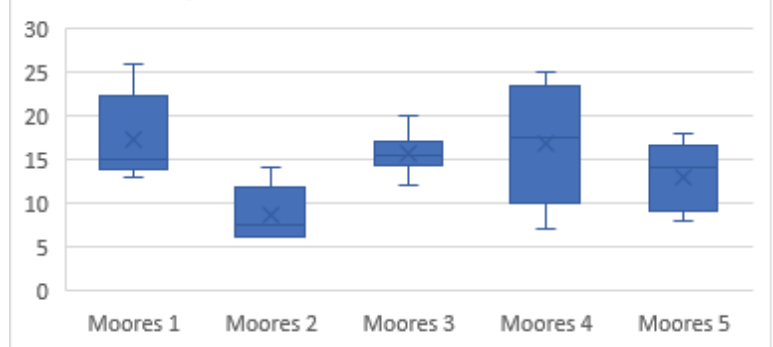
Diversity Scores Across Moore's Creek Sites

- When comparing 1992 to 2016, development in Moore's Creek appears to have occurred in land uses designated as "Other". This designation includes row crops, grassed or shrub "scrub", and barren land.
- Moore's Creek contained two sites with below average diversity and two with average diversity.
- The average percent of silt, clay, or mud observations were high and Moore's Creek had the lowest average observation of cobbles across all locations.
- Despite its rural setting, incision and erosion are commonplace across the watershed indicating historic channel straightening, loss of wetlands, loss of riparian forests, and/or damage from livestock access (which contribute to erosion and increasingly steep streambanks).

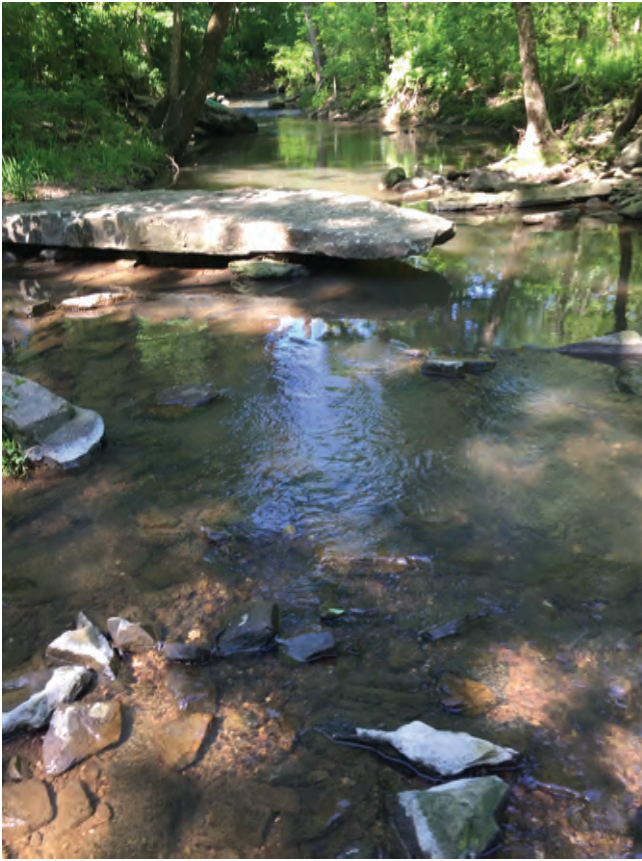
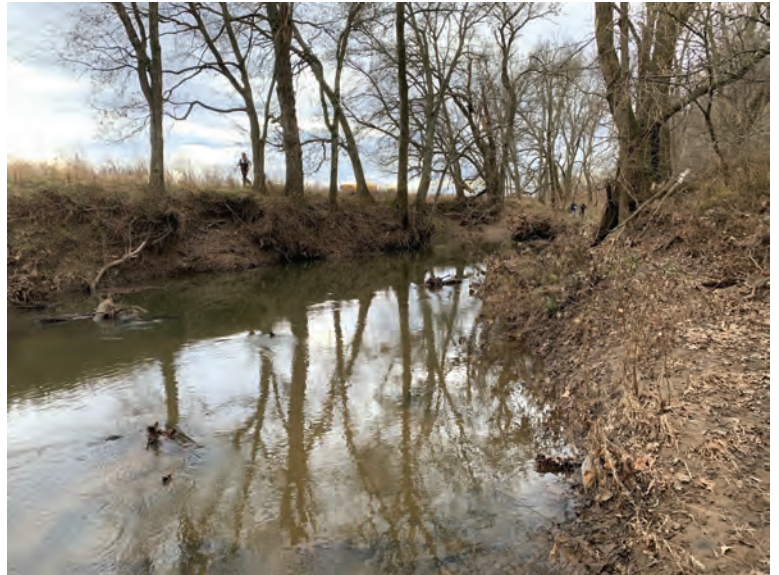
Visual Comparison of Sites with High and Low Numbers of Gravel and Cobbles Observations:

The site of the left, located upstream of Lincoln Lake, is a good example of the diversity of stream habitat that is needed to support diverse macroinvertebrate communities. The creek is on the same elevation as the surrounding land use, indicating no incision or erosion is occurring. And there is a wide variety of rock sizes, surface types, and flow regimes that macroinvertebrates can utilize. The site on the right, on the other hand, is incised and eroding, contains turbid water (indicating deposition of silt and mud), and lacks variation in habitat (i.e. no riffles, runs, or pools).

1. Re-establish riparian forests, wetlands, and floodplains.
2. Permanent or semi-permanent conservation of areas around headwaters and/or forested hillsides.
3. Sustainable livestock practices such as rotational grazing and fencing cattle out of streams.

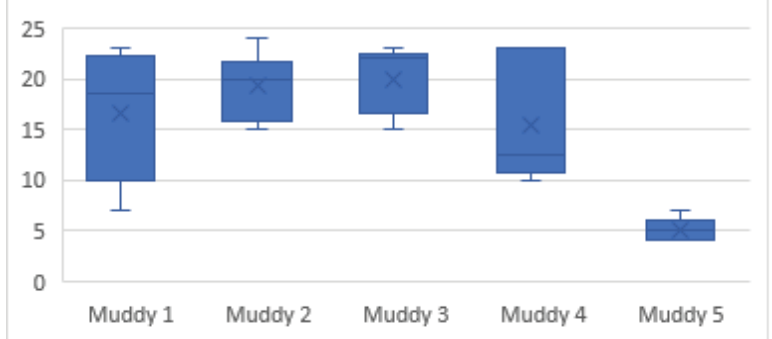
Diversity Scores Across Muddy Fork Sites

- Similar to Moores Creek, Muddy Fork also experienced a 5% increase in urban land use (likely from expansion of Prairie Grove to the North), which occurred in the "Other" land use designation.
- The overall average diversity score across all sites in the subwatershed was average for Arkansas sites, but Muddy Fork did contain one of the least diverse sites across the entire project.
- Muddy Fork had the second highest percent observations of silt, clay, and mud; second only to Moores Creek.
- Also like Moores Creek, erosion and incision are common in the subwatershed.

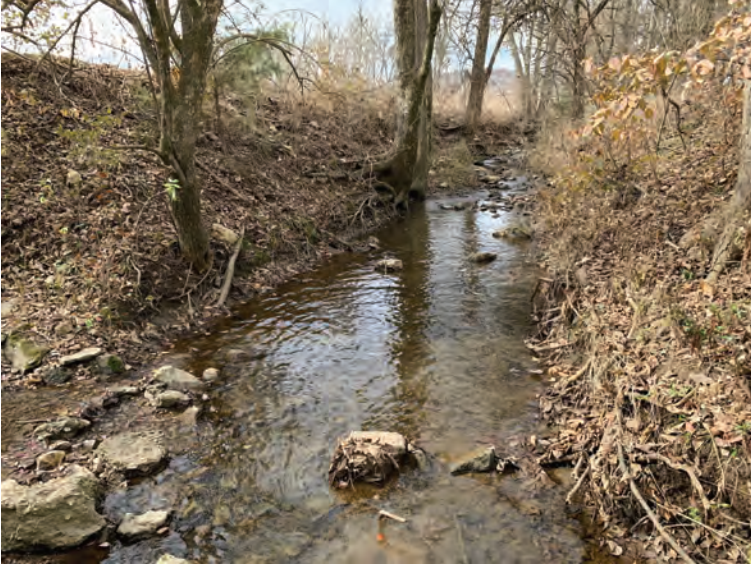
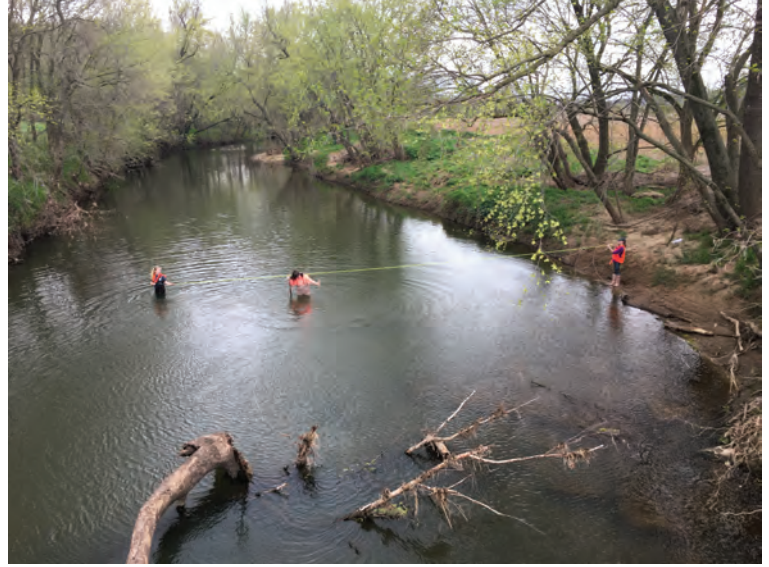
Visual Comparison of Sites with High and Low Numbers of Gravel and Cobbles Observations:

The left-hand site is a small creek that runs through pasture lands with little riparian forest. The streambank is somewhat incised and the reach may have been trenched at sometime in the past. The right-hand site is a good example of stable streambanks with little incision. On the other hand, the stream is deep throughout with few riffles, which indicates degradation of the stream bottom composition that is necessary for diverse communities.

1. Re-establish riparian forests, wetlands, and floodplains.
2. Permanent or semi-permanent conservation of areas around headwaters and/or forested hillsides.
3. Sustainable livestock practices such as rotational grazing and fencing cattle out of streams.

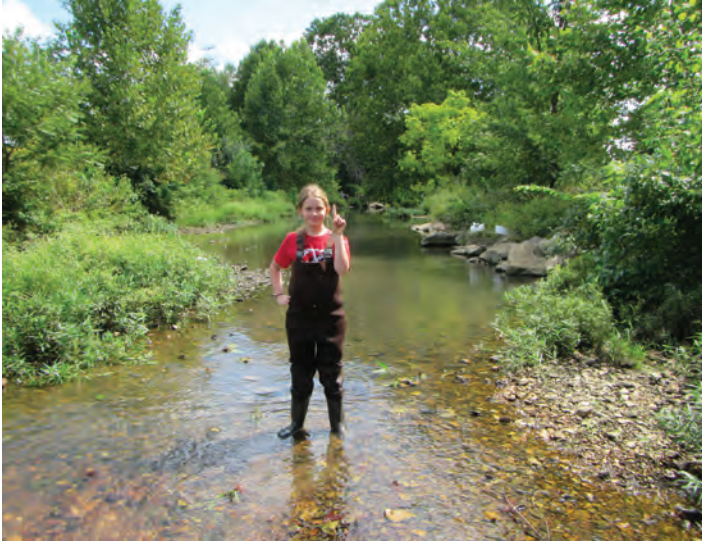
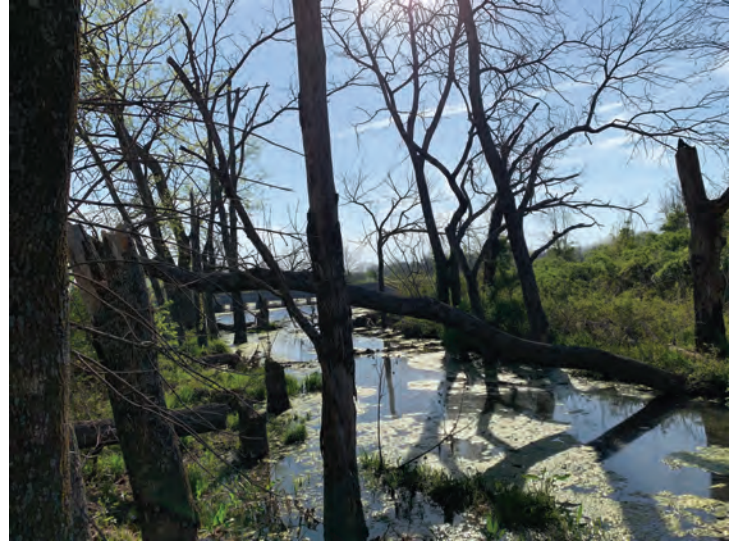
Visual Comparison of Sites with High and Low Numbers of Gravel and Cobbles Observations:

The site in the left-hand photo demonstrates healthy riparian vegetation that has been re-established in the last 15 years by the City of Siloam Springs. There is no active erosion and little silt, clay, or mud in the streambed. While not aesthetically pleasing, the photo at right is a site that is a mix of wetland, stream, and stormwater detention feature that is located upstream of the left-hand photo site. The presence of silt, clay, and mud at this site was very high, but not unexpected given its function.

1. Low impact development features on all parcels with impervious surface.
2. Permanent or semi-permanent land conservation on headwaters and upstream portions of the watershed.
3. Continued stream and riparian restoration projects.

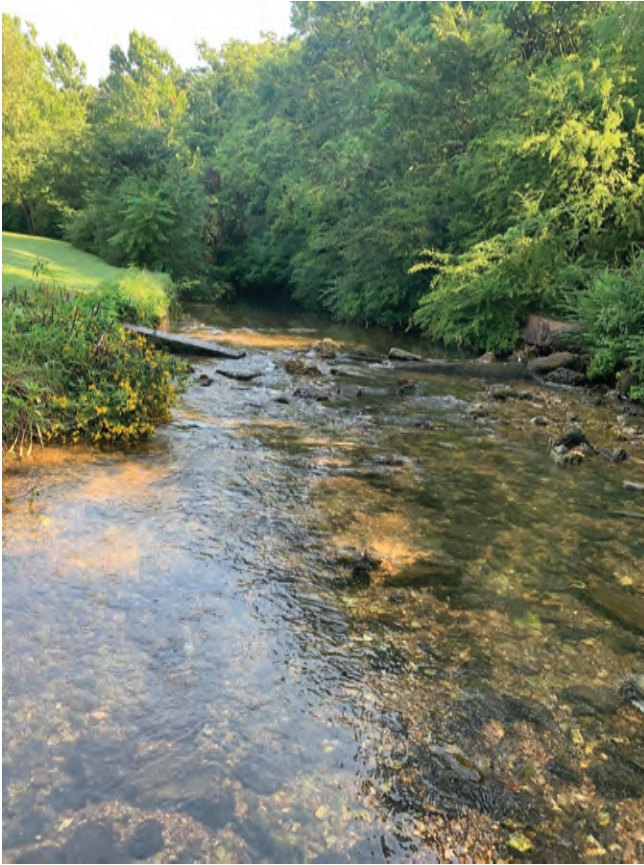
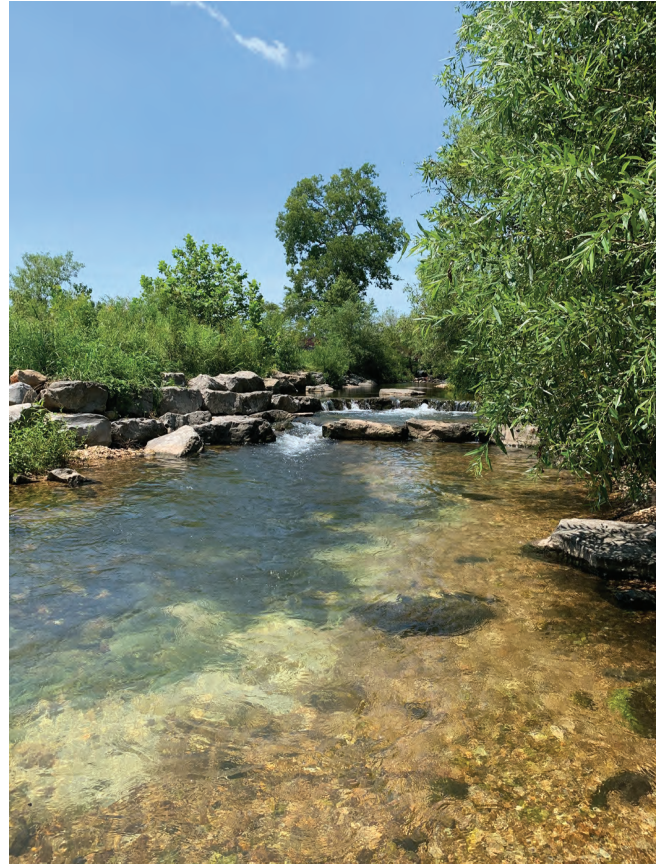
Visual Comparison of Sites:

The site at left represents a typical Town Branch stream reach in Tahlequah: a mix of lawn, urban forest, and low density residential or commercial development. The site at right is the restored site, with in-stream features, structured pools, runs, and riffles, and re-established riparian vegetation.

1. Low impact development features on all parcels with impervious surface.
2. Permanent or semi-permanent land conservation on headwaters and upstream portions of the watershed.
3. Continued stream and riparian restoration projects.
